**HISTORIC BUILDING ASSESSMENT**

**21 AND 23 WALLINGFORD STREET, WANTAGE**

**STRUCTURAL REPORT**  
21 & 23 Wallingford Street, Wantage

Issue 1: 15 November 2011  
Ref: TR290609/MW/DW/045

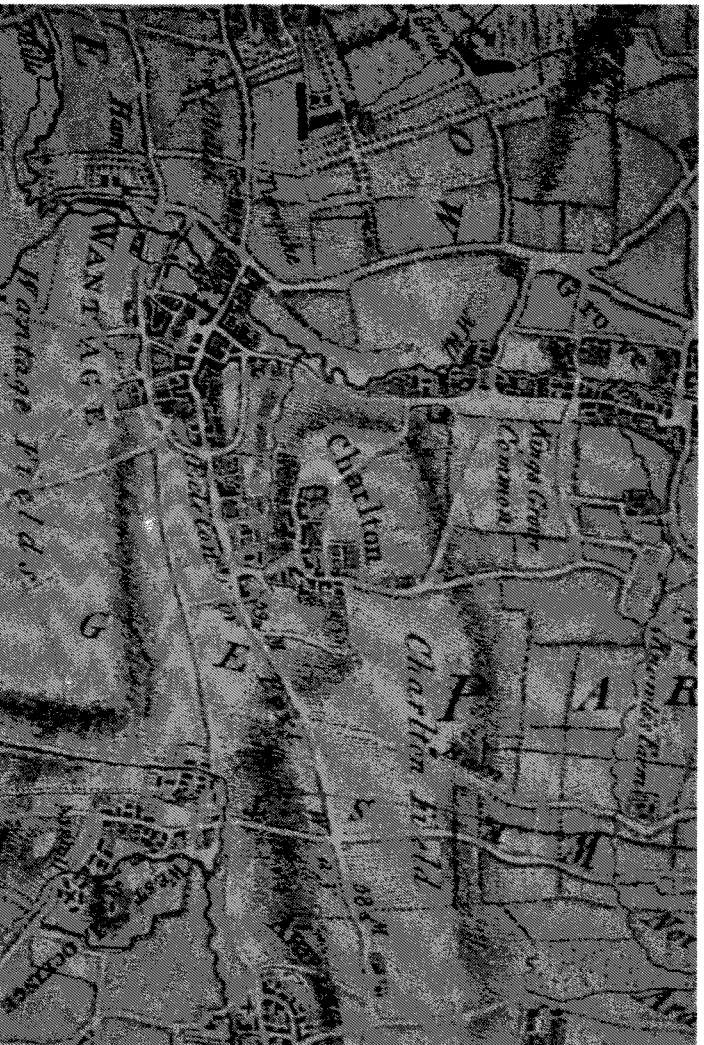
Figure 1. Rocque's map of 1761 showing the plots 21 and 23 on the north side of Wallingford Street .

2.2.7 The buildings known as 21 and 23 Wallingford Street are shown on Rocques map of 1761 (see figure 1); if the back ranges are there it is not overly apparent although their lack of inclusion is no indication that they were not constructed at this time. The first series OS map of Wantage in Berkshire dated c. 1885 appears to show extensions on a number of buildings in the vicinity of nos. 21 and 23 (not illustrated).
